Penetrations and Closeouts

We look at methods and materials for preventing water intrusion in new cored-panel construction and in retrofits.

by Bruce Pfund

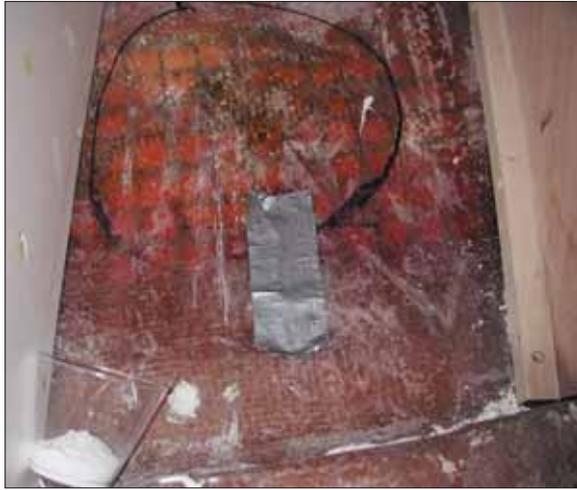
The water in the core kerfs of this large motoryacht developed an unpleasant smell and blackened the PVC foam core in less than 18 months. Shown here is a leak into the master head's vanity at a self-tapping screw location.

Returning to the yacht with the foul-smelling interior: the water in the kerf system reached the vessel’s interior through hundreds of self-tapping screw penetrations through the inner skin. Some were for securing furniture

and joinerwork; others, for pipes, ducts, wiring harnesses, headliners, and upholstery. Murphy's Law proved true once again: not all the fasteners went into core blocks; enough of them penetrated the kerf system to let kerf water drain through the inner skin into multiple interior living spaces and belowdeck compartments. Surprisingly, some leakage also was occurring around the gland nuts on the interiors of a number of through-hulls—a strong indication that the core had not been closed out at those locations.

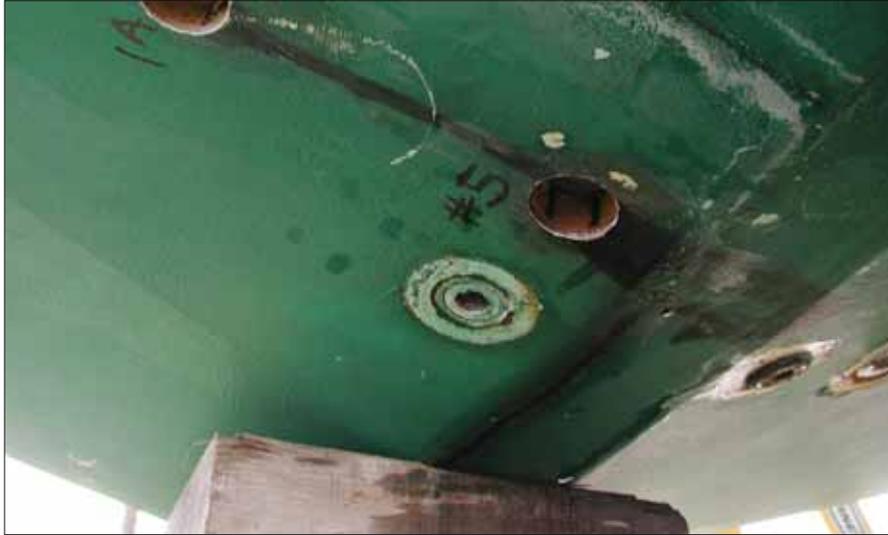
Upper left—On the cored boat pictured here, the author first drilled holesaw rings through the outer skin at approximately 6' (1.8m) intervals, and the drainage rates at each hole were drip by drip. He then drilled another hole halfway between the first two (labeled 1A), and the aft hole's (#5) drainage rate increased to a steady stream, indicating a discontinuous bleed path between the two original holes.

Discontinuous bleed paths often become apparent when a series of exploratory, test-coupon, or drying holes are drilled in wet panels. On one project, I first drilled holesaw rings through the outer skin at approximately 6' (1.8m) intervals, and the drainage rates at each hole were drip by drip. I then drilled another

hole halfway between the first two, and the aft hole's drainage rate increased to a steady stream. It was not until I drilled another hole forward of the original front one that the

aft hole began to drain at the same speed as the others.

My interpretation of this is that the partial vacuum affecting the kerf system adjacent to the aft hole was not

broken when I drilled the second hole 6' forward. My drilling the intermediate hole, though, broke the vacuum. Let's return to the plastic-straw demo for a moment. Immerse the open straw in the water, let it fill, then seal the top with your fingertip. Next, withdraw the straw from the water, and note that very little water escapes—until you unseal the straw's top by lifting your fingertip, thereby releasing the vacuum. The fact that the forward hole drained slowly until I punched another hole forward of it indicates a discontinuous bleed path between the two original holes; there was no airflow into this region from core penetrations farther aft.

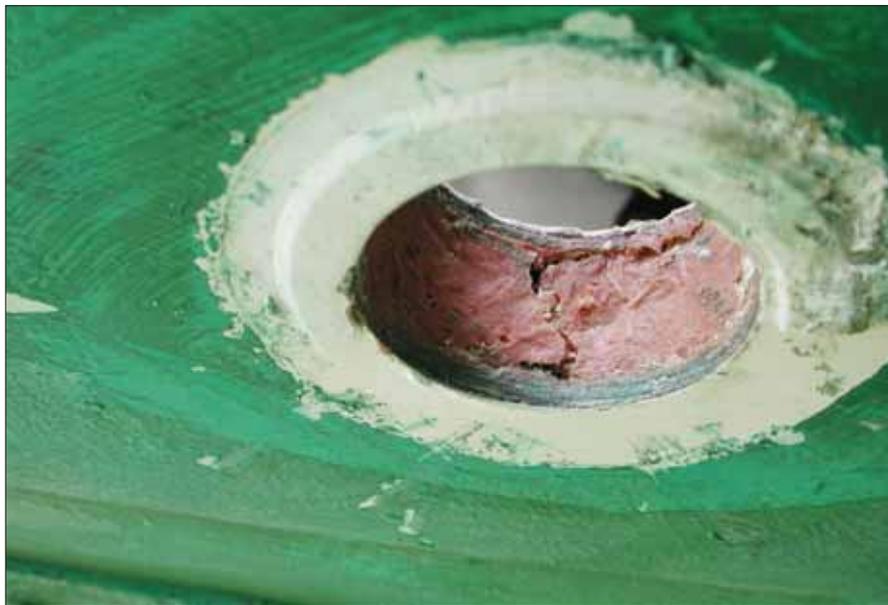
Above—Another through-hull penetration, on the same boat as the upper left photo. Core around the hole had been removed and the hole backfilled—apparently with a glass-fiber-filled putty—but only to a depth of about $\frac{3}{16}$ " (4.8mm). The putty collar is cracked, as are its bonds to the inner and outer skins—probably caused by over-tightening of the through-hull during installation. Backfilling to $\frac{3}{4}$ " (19mm) or more would have provided bigger bondlines and improved compressive strength.

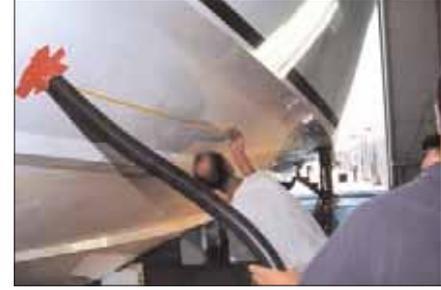
Upper right—Two $\frac{1}{4}$ " (6mm) holes were drilled into this contour-cut panel's kerfs, approximately 8' (2.4m) apart. A shop vac was hooked up to one hole, a lit cigarette placed in the other. The cigarette glowed bright red and disappeared about 10 seconds after the shop vac was turned on—a graphic demonstration of cross-flow in an unfilled core-kerf system.

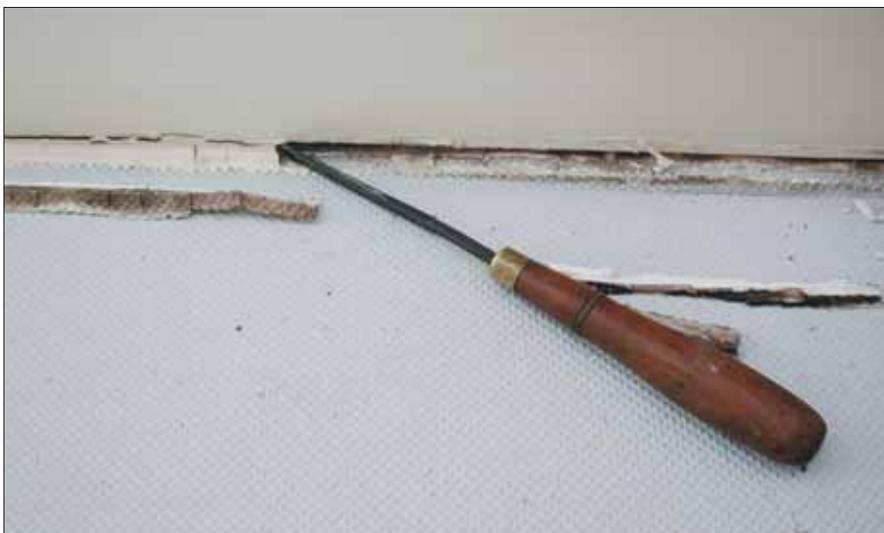
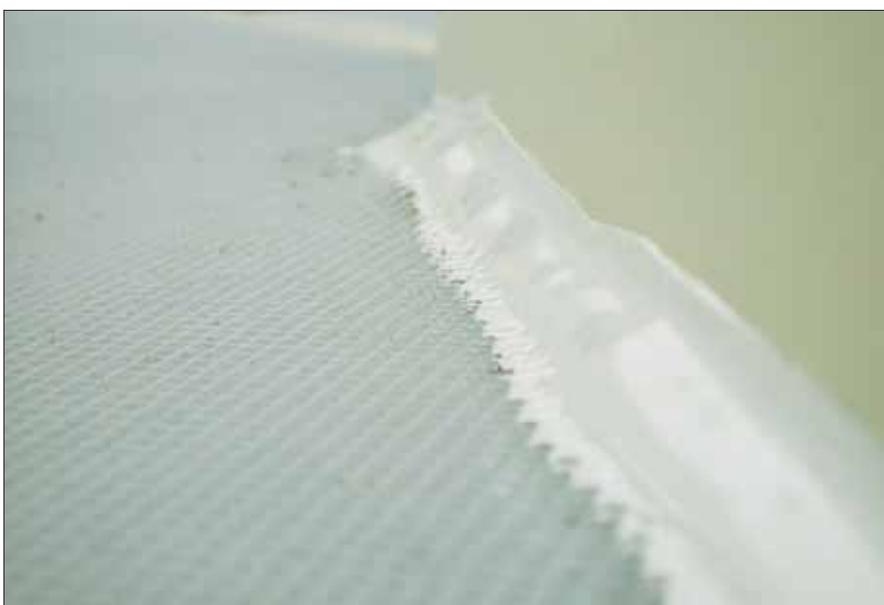
*Thermal expansion and contraction of air in a cored part can draw water into a core. **Top**—On the author's boat, part of Spring refitting was to scrape each channel of the cockpit sole's nonskid texture, where the console joined the sole. The bead of 5200 would stay adhered to the console surface, but debond from the nonskid surface—even though he acetone-scrubbed it with a Scotch-Brite pad before applying new sealant. **Above**—Expanding air inside the cored console panel deflected a concave bead of sealant to this convex condition. Once the sealant hardened and was less easily deflected, the same pressure caused the sealant to release from the nonskid. When the air in the console cooled and contracted, water puddled on the sole was drawn up into the core. **Above, Right**—A bow light was installed at the upper edge of this cored sailboat's topsides. Over the years, water intrusion caused extensive core damage, because the wet core was constantly refreshed with new air as the hull breathed in and out at this high point.*

I learned about the “thermal pumping” phenomenon firsthand on my own fishing boat. The cuddy console, which was cored with 5"-square (127mm) blocks of 3/4" (19mm) plywood, was tabbed to the cockpit sole only on the inside console faces. The outside surfaces were not bonded,

but rather just “sealed” to the sole’s nonskid with a thick bead of 3M 5200 polyurethane adhesive-sealant. The problem was that, no matter what I tried, the 5200 never stayed stuck for more than a few weeks at best.

In one of my repair attempts, I scraped and acetone-rubbed the surfaces with a Scotch-Brite pad, and again applied a bead of fresh 5200 to the cleaned surfaces. I ran my filleting tool down the bead to produce a lovely radius, and then went up to my shop for a cup of coffee. The sun was beating down hard on the hull. When I came back about 20 minutes later, my perfectly concave putty fillet had become a bulging convex mess, and in one thin spot had actually popped a bubble through to the surface. I finally figured out what was causing this excellent product to fail so quickly: The air in the spaces between the plywood block core was expanding as the console was warmed by the sun, and that pressure

was deflecting the soft bead of uncured 5200.

I then realized what had been happening: after a new bead of sealant had hardened for a few weeks, it was forced off the nonskid. On a nice hot day, a passing shower would go by, rapidly cooling the console and the air inside it, while also depositing a puddle of water onto the cockpit sole. The air in the console core would contract, and since the core’s vent to the atmosphere was underwater, that contraction caused water to be drawn up into the core. Did I mention that attaching cored consoles to decks with this method is not one of my favorite construction details?

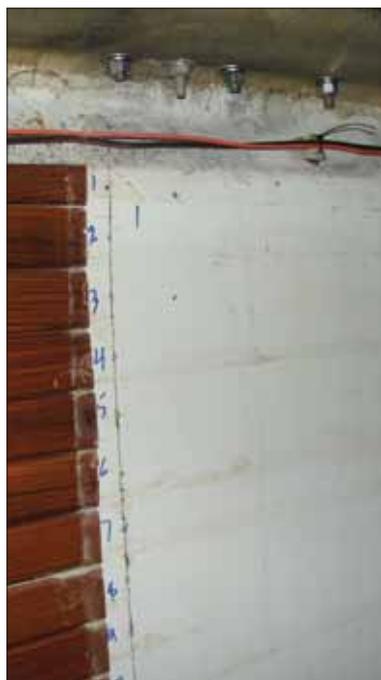
Left—The builder of the sailboat pictured here adhesively bonded the attachments for tie-wraps, but drilled hundreds of holes into the inner skin to secure wood trim slats throughout the boat’s interior. It’s unlikely that water will enter the kerf system through the screw holes in the topsides, close to the hull-to-deck joint. Some of the holes, though, will serve as vents for the kerfs—half the equation for water movement through the kerf system. **Center top**—These stainless steel mounting flanges, manufactured by Bighead, are equipped with perforated bases for adhesive bonding to composites. With the proper high-viscosity, fast-setting adhesive, installation is often place-and-forget, with no clamping or fixturing required. **Center bottom**—Every wiring-harness hanger location on this sailboat had integrally infused foundation blocks of solid core material. The fastener and pilot hole were correctly sized to penetrate the foundation only, and not the hull’s inner skin. **Right**—Fresh out of its blister pack, this #10 self-tapper had contaminants—thread-rolling and cutting lubricants—on the threads (the black bands on the cloth, corresponding to the threads, came off on the cloth with a wipe). These contaminants can compromise the bond between fastener and sealant.

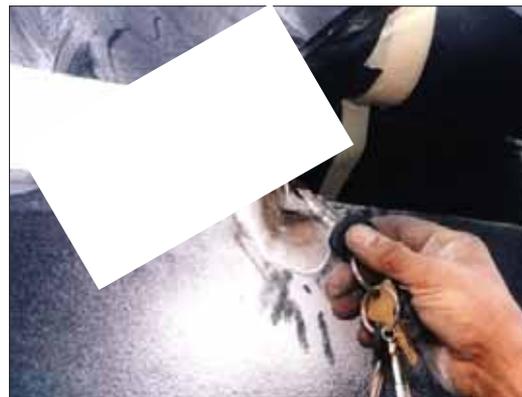
Scuppers and drains should be treated the same way as cored-panel penetrations below the waterline. This scupper tube was laminate-taped on the inside, but only puttied and painted on the outside. After five years in service, it was surrounded by a wide margin of wet and rotted core.

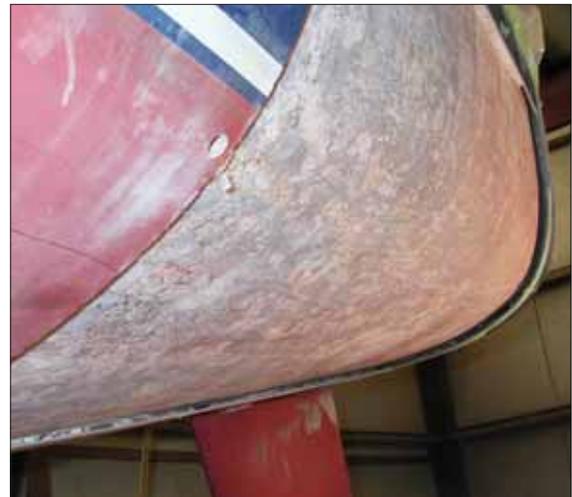
Of the region undergoing core replacement, three sides have outer-laminate overhangs that trap 3" to 6" (76mm to 152mm) of core. The laminates were left in place so the repair's scarf zones would not run around the transom corner, destroy the molded-in cove stripe, or enter the solid-laminate region at the hull centerline.

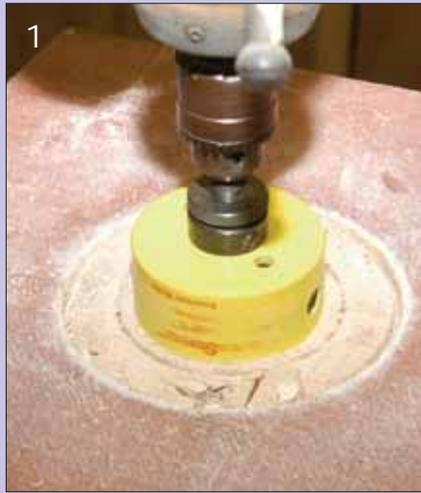
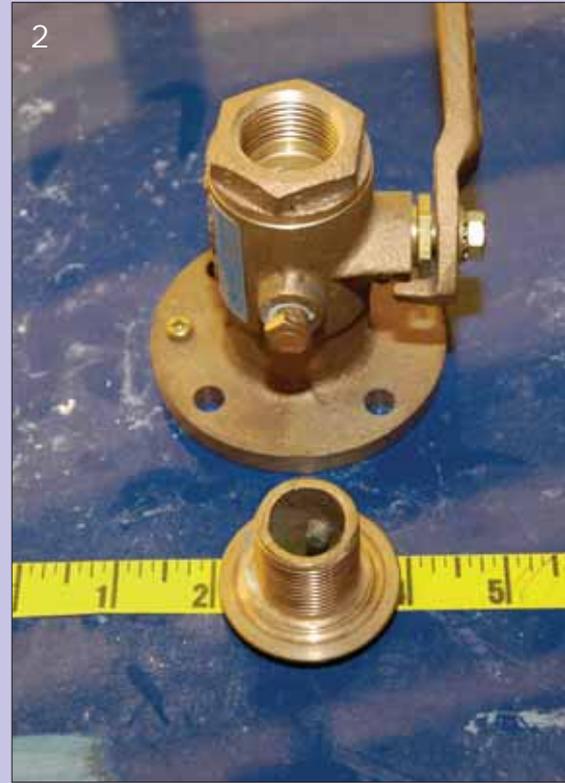
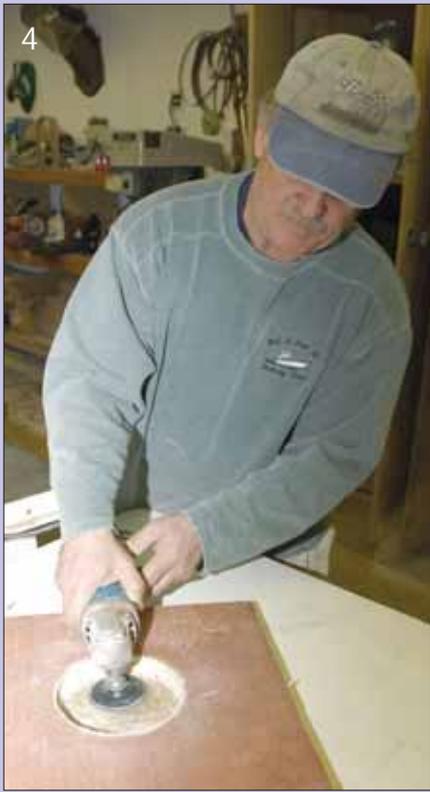
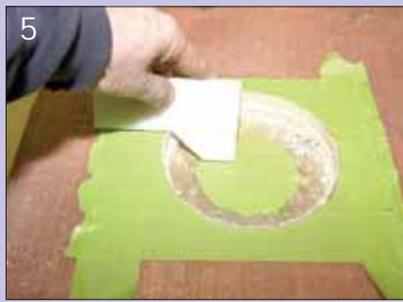
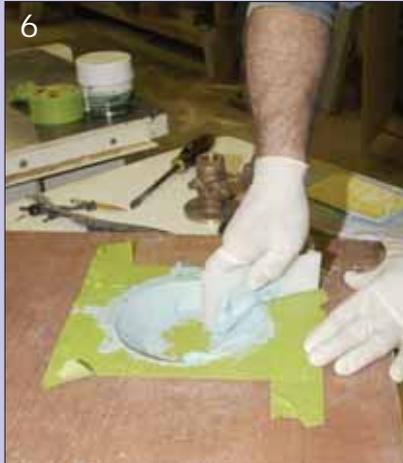
The numbered images here and on the next page illustrate the sequence of steps involved in closing out the core at a through-hull penetration by bringing the skins together. Brian Lenahan, head of composites and carpentry at Brewer Pilots Point Marina (Westbrook, Connecticut), demonstrates each step.

1. Drill a 1/4" (6mm) pilot hole through the sandwich panel. Then, holesaw the inner skin and core. For this step, switch to a smooth 1/4" drill rod for the holesaw's arbor, or turn the arbor drill around in the holesaw, so the alignment hole in the panel's outer skin does not get chewed up by the drill's flutes. Using the largest holesaw required, cut the inner skin and pop the laminate disc off the core. Next, make a series of concentric holesaw cuts through the core, just to the outer skin, to make the core easier to remove. Do not drill the bore for the fitting at this time. Only a 1/4" (6mm) hole should penetrate the outer skin. Take care when cutting the core and levering out the pieces on thin-skinned panels. It may be safer to rout or grind away the core if the outer skin is delicate. 2. The seacock flange shown here is approximately 4" (102mm) in diameter, so the solid-laminate disc should be a minimum of 5" (127mm) in diameter. Including the putty fillets for the 1" (25mm)-thick core, the largest holesaw required for this procedure measures about 7" (178mm) in diameter. 3. Diagram of a cross-section through a chine showing inner and outer skins brought together to close out the core. Note fillet strips along core edges, tapered transitions, laminates overlapping onto core edges, and plenty of room to work. Stopping the core well away from the chine prevents core bridging, and also produces a thick, solid laminate in way of an area that often gets point-loaded by support stands and blocking.

4. Grind away any core material left behind on the inside surface of the outer skin. Avoid overheating the laminate, which could cause a color change or dimple in the exterior paint or gelcoat. 5. Special tools can make the filleting job much easier. This bevel-squeegee was made from 1/8" (3mm)-thick polyethylene sheet stock, but could just as easily have been razorknife-cut from a plastic putty spreader or piece of Formica. 6. Prime the core edge and laminate with catalyzed vinyl ester resin. Using a paint-stirring stick, pack the bevel region with a low-shrink, low-exotherm, BPO-catalyzed polyester-based filleting putty. (The author advises against making your own with laminating resin and MEKP catalyst or core-bonding putty.) Then, sweep the squeegee 360° around the hole, making a uniform putty bevel. 7. Remove both inner and outer pieces of masking tape immediately after the last sweep of the fillet squeegee, before the putty begins to gel. 8. In this sample, two layers of 1808 stitched bi-ax with mat were required to match the original laminate schedule. Lenahan cut two concentric discs, one approximately 4" larger in diameter than the other. He cut four darts in each disc, but offset them 50% to prevent any gaps in the laminate patch. He laid these plies down into the filleted recess largest ply first. 9.

- *Bringing the skins together.* This method is also appropriate for new construction or retrofit. During new construction, the closed-out area is created by applying tapered edge strips of core material around the location's perimeter. Lenahan did not have a cored boat in his shop that needed a new through-hull. So, to illustrate closing out the core by bringing the inner and outer skins together, we used a balsa-cored test panel about one sq yd (0.8m²) in size that I had in my shop. The panel's core was 1" (25mm) thick, the skins about $\frac{5}{32}$ " (4mm) thick. We did use a drill press, which wouldn't be practical for a retrofit, but if you substitute a handheld drill big enough to spin a

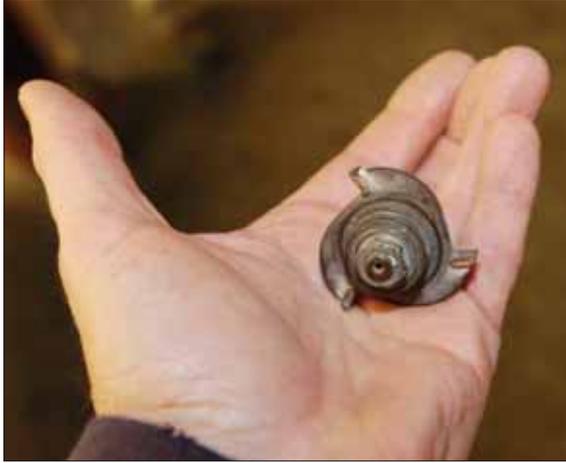
This three-bladed cutter's ball-bearing standoff collar can be switched from side to side, so that core can be reefed out of bore edges from one side only. It's important not to tilt the cutter too much, or it will dig into the laminate.

around a lot less than a two-blade flycutter. It removes about $\frac{3}{8}$ " (10mm) of core back from the hole's edge when the ball-bearing spacer bushing on the arbor hits the sidewall of the hole." Lenahan switches the ball bearing from one side of the cutter to the other to track the inside and outside skins of the panel, and noted that after the first pass with this cutter he then sometimes switches to a bigger one to remove about another $\frac{3}{8}$ " of core depth, creating a backfill zone approximately $\frac{3}{4}$ " (19mm) deep.

Lenahan pulled a three-bladed flycutter head (**above**) out of his tool cabinet and explained that he liked it for cutting away core material around through-hull bores holesawed through hulls and decks. "This one isn't too spooky to use. I can run this cutter on my high-speed router, cordless electric drill, laminate trimmer, or air-operated sanders and grinders. With the three chipper teeth, it jumps

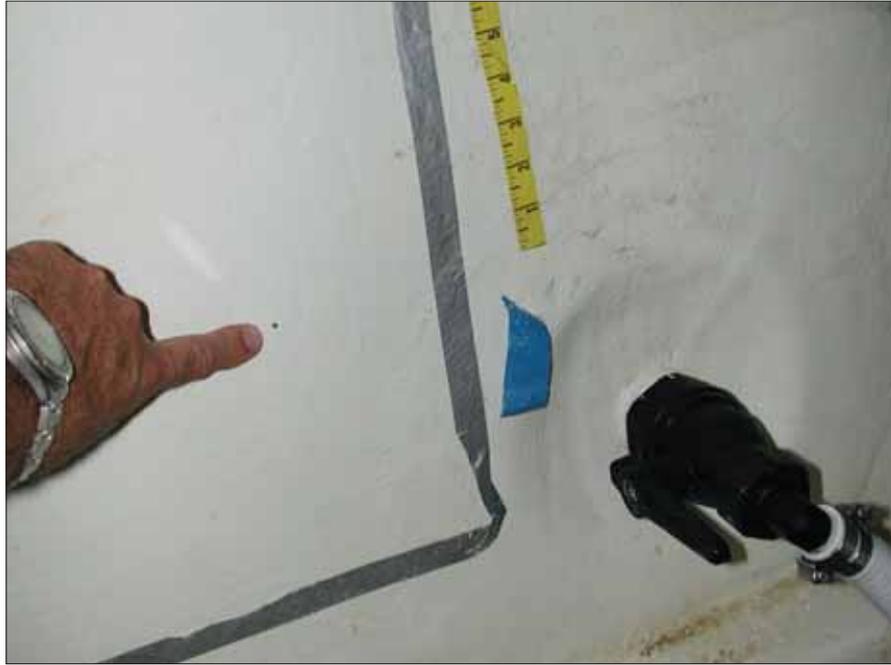
A core closeout for a lightweight Marelon composite fitting and valve, built into a vacuum-bagged, wet-preg, cored hull. Note the concentric laminate patches and their offset darts.

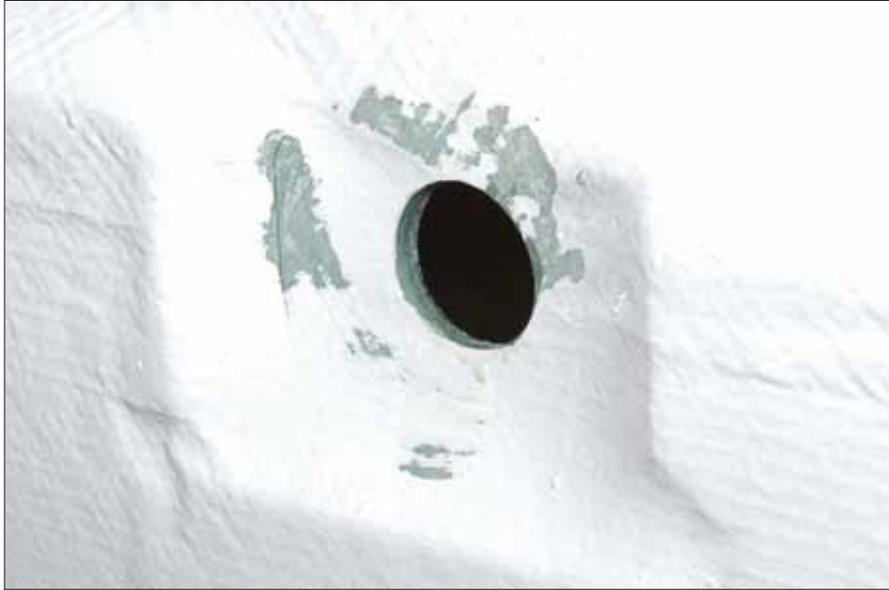
At Boston Boatworks, where vacuum-bagged wet-pregs are the standard, through-panel penetrations are closed out to a single skin with tapered edge strips of core and additional laminate patches. The inside surface is ground after application of interior finish to ensure a flat landing for the through-hull's gland nut.
